Manhole Inspection Summary

Manhole # S45E__045MH

Insp Date: **8/14/08 9:08 AM**

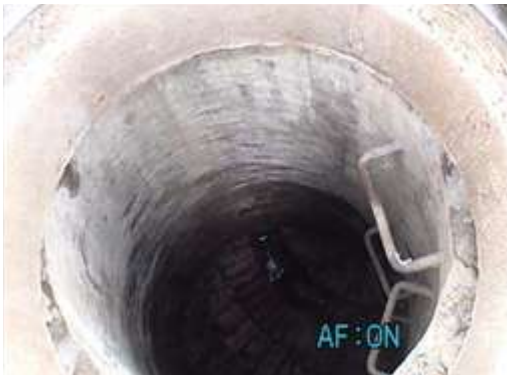
Defect 2

Frame Offset: **2** (in.) Condition: ☐ Sound ☐ Cracked ☒ **Leaks**

Frame leaks

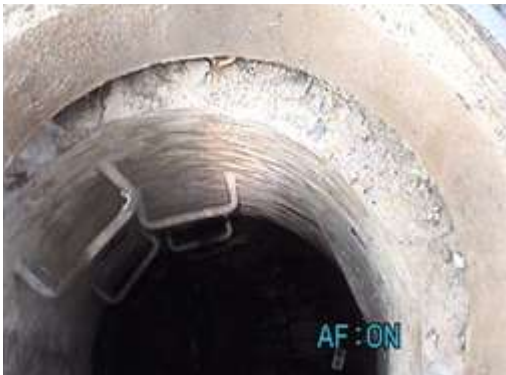
Defect 1

Infiltration: ☐ None ☒ **Joint** ☐ Cracks ☐ Mortar ☐ Roots ☐ Wall

Infiltration: ☐ None ☐ Joint ☐ Cracks ☐ Mortar ☐ Roots ☒ **Wall**

Infiltration

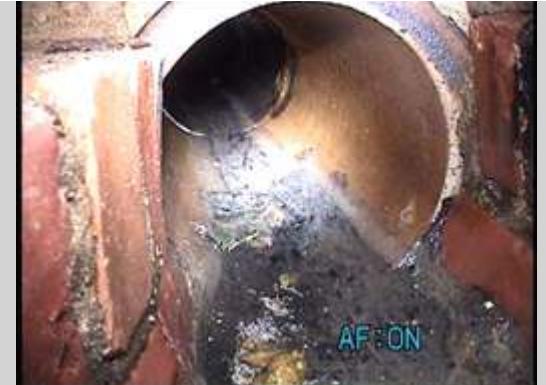
12 O'Clock Outflow

Pipe Height: **8.4** (in.) Rod and Bar (Angled)
Pipe Material: **Clay** ☐ Pipe Lined
Invert Depth: **10.90** (ft.) Flow Characteristics: **Slow**
Deposits: ☒ None ☐ Mud ☐ Sludge ☐ Debris ☐ Grease
Silt Depth: (in.) Deposits Extent:
Infiltration: **None** Pipe Seal Cond: **Sound**

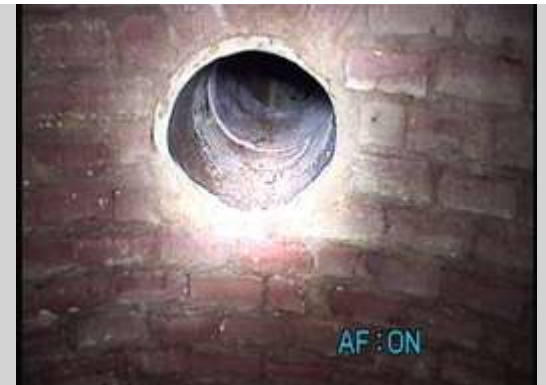
9 O'Clock Inflow

Pipe Height: **8.4** (in.) Rod and Bar (Angled)
Pipe Material: **Clay** ☐ Pipe Lined
Invert Depth: **8.90** (ft.) Flow Characteristics: **Slow**
Deposits: ☒ None ☐ Mud ☐ Sludge ☐ Debris ☐ Grease
Silt Depth: (in.) Deposits Extent:
Infiltration: **None** Pipe Seal Cond: **Sound**

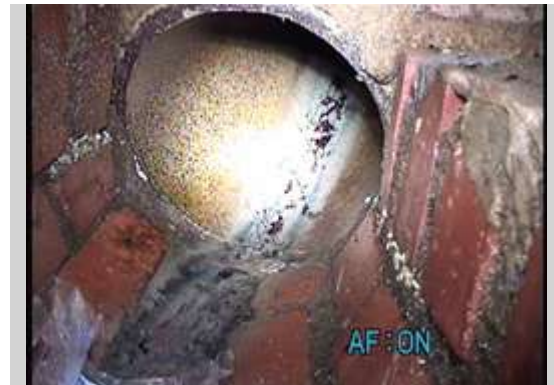
Drop In @ 9 O'Clock

Drop: **Inside** Rod and Bar
Angled: **Yes** Reading: **9.80** (ft.)
Inv Depth: **10.80** (ft.)
Drop Condition: **Open**
